Titanic, The Anatomy of a Disaster
A Report from the Marine Forensic Panel (SD-7)

ABSTRACT

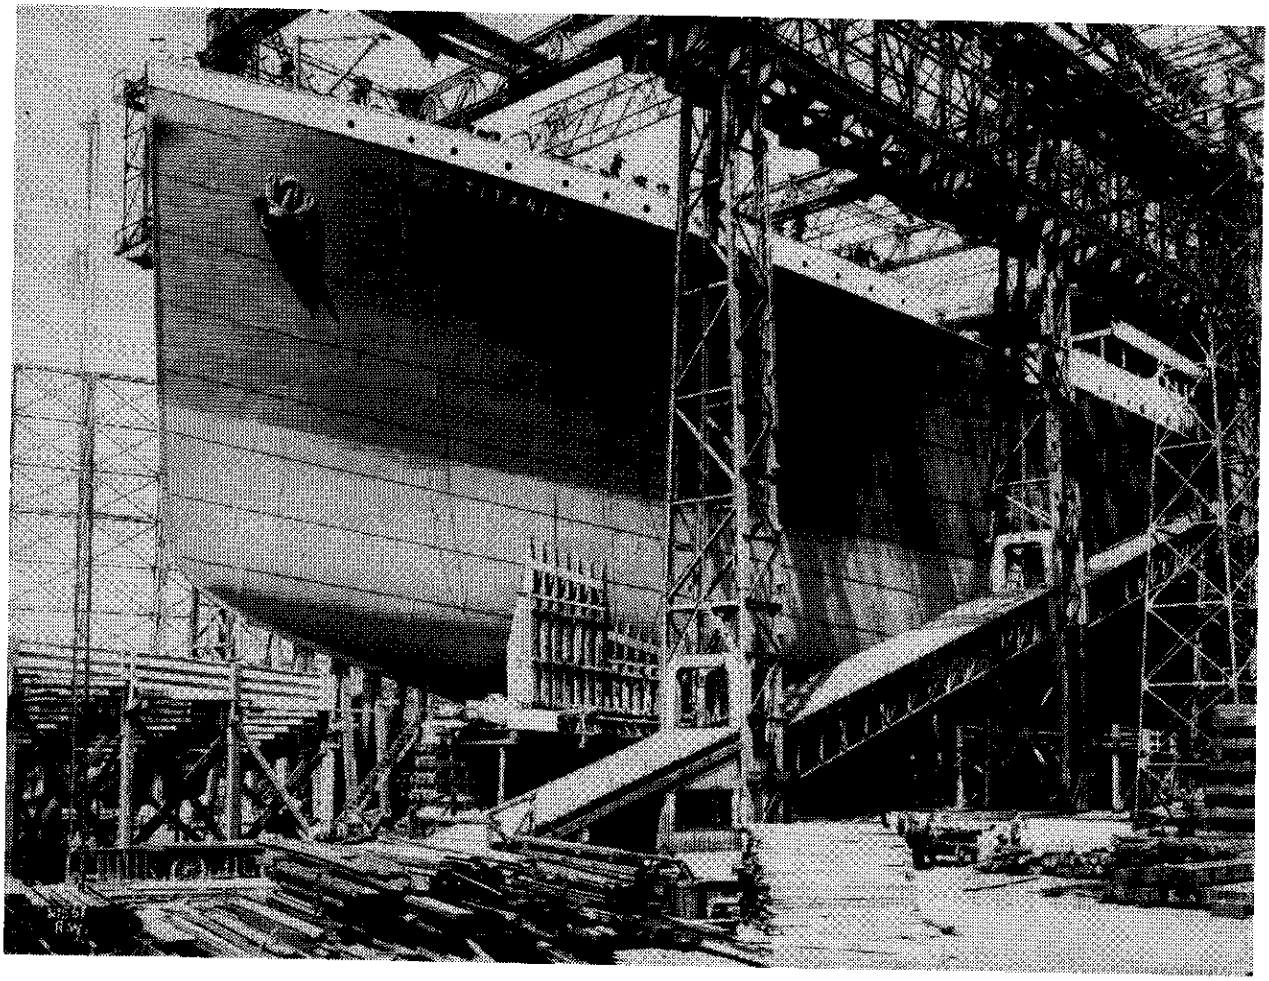
The Titanic is perched on the building ways at Harland and Wolff Shipyard on May 31, 1911 several hours before her launch. Note that the second full plate within the boot topping is the plate that sustained damage from the encounter with the iceberg on April 14, 1912. (Courtesy of the Ulster Folk & Transport Museum)

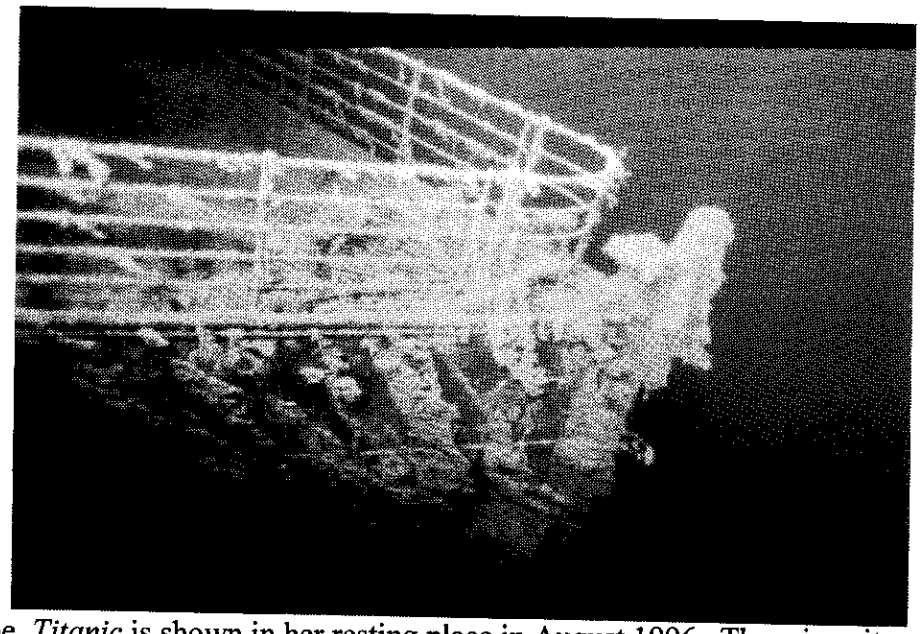
The bow of the *Titanic* is shown in her resting place in August 1996. There is quite a difference between the ship on the ways and in the advanced state of decay. About 20% of the hull has been consumed by "rusticles" which are large colonies of bacteria that are leaching out the iron and other elements in the hull. We estimate in approximately 200 years, the wreck will have collapsed and the elements will be combined with the bottom ocean sediments (Courtesy of RMS Titanic, Inc).

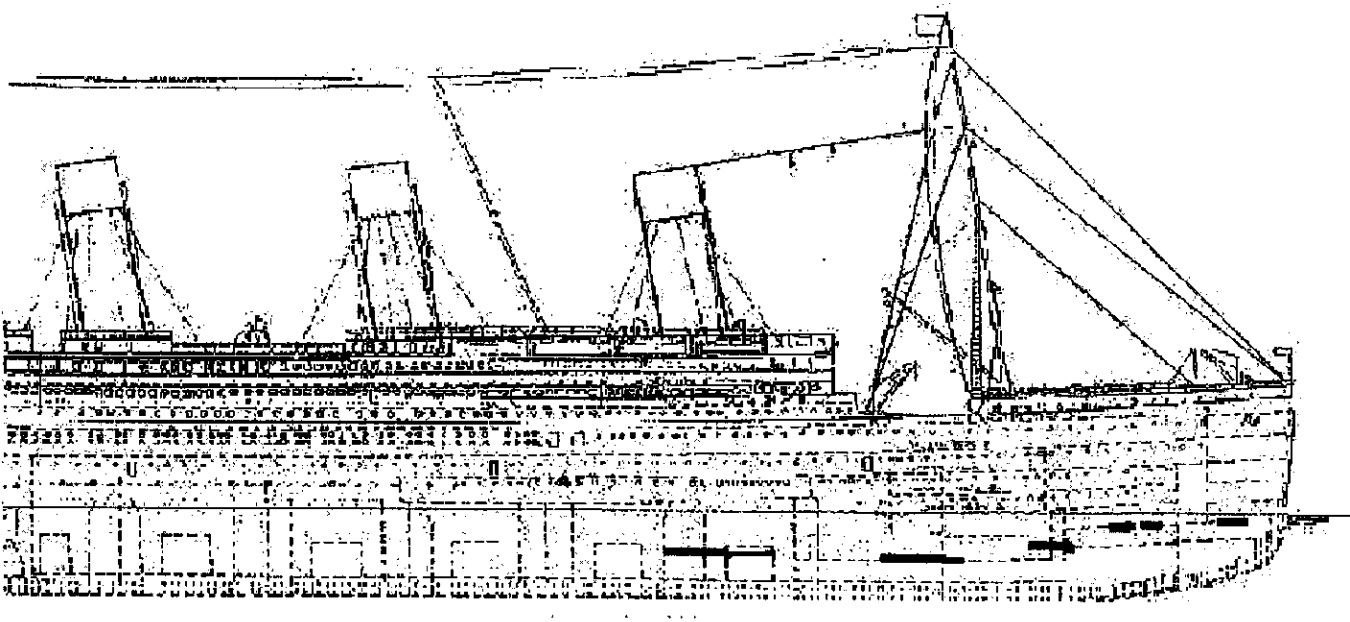
Figure 1 <u>Illustration of the Iceberg Damage</u>

The top portion of the riveted seam of the first full plate below the boot topping was opened in the forepeak and cargo hold number 1. As the ship-iceberg envounter continued, there was fracturing and tearing of this plate between cargo holds Nos. 1 and 2, and parting of the lower portion of that plates riveted seam between Cargo Holds Nos. 2 and 3 and Boiler Rooms Nos. 5 and 6.

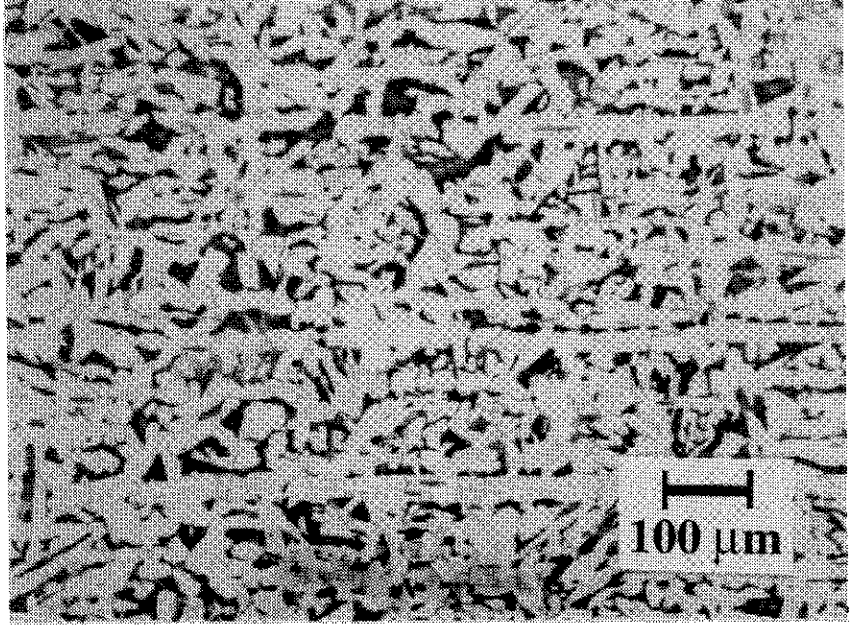
Figure 2

The sulfur content of this steel is important in understanding the fracture mechanics of the hull failure of the *Titanic*. Sulfur and manganese react to form manganese sulfide. Without manganese, the steel would have iron sulfide formed at the grain boundaries. The iron sulfide has a low melting point so the steel ingot would have a grain boundary envelope which, at rolling temperatures, would be molten. Since a liquid phase will not resist shear stresses, hot work (e.g.: by rolling) would

An optical micrograph of the *Titanic* hull plate in the longitudinal direction.

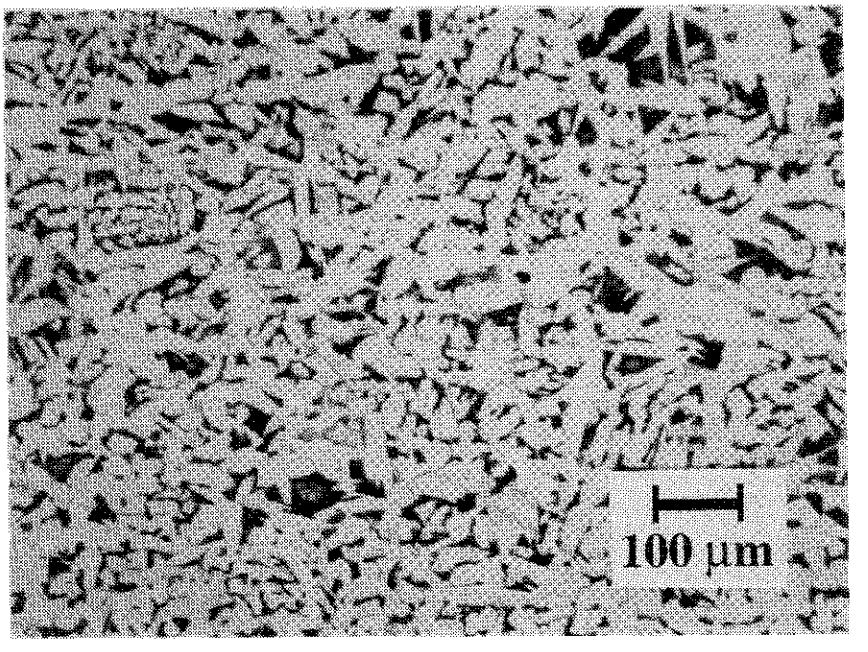
Figure 3

An optical micrograph of the *Titanic* hull plate in the transverse direction.

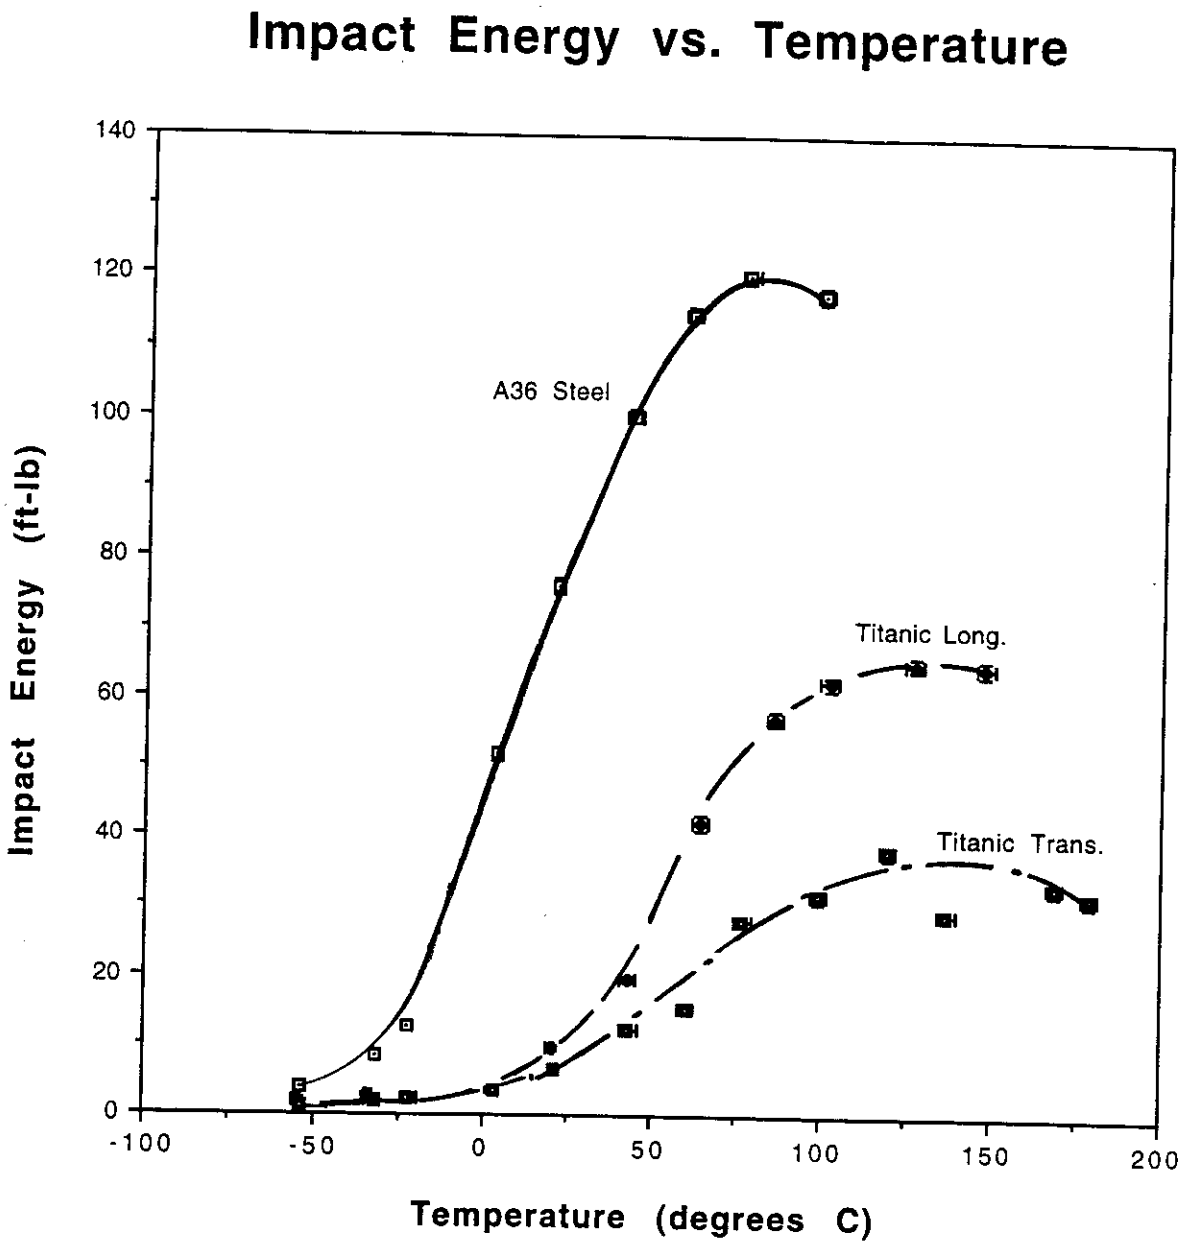
Figure 4

Charpy V-Notch Test of *Titanic* Steel Versus a Modern A 36 Steel

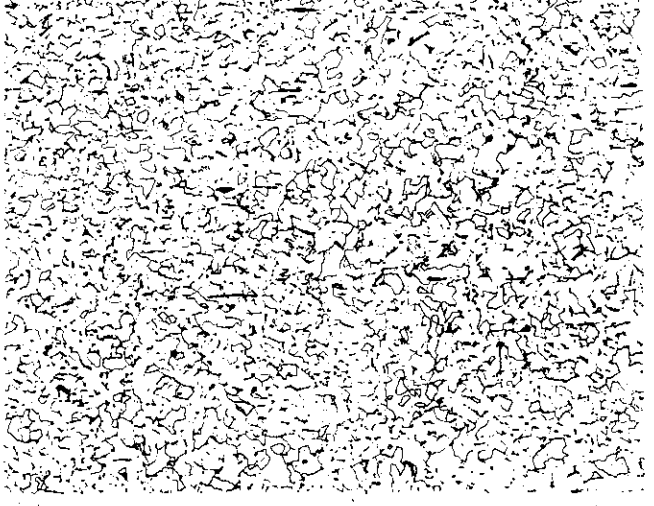
Figure 5

Nomadic Plate, Longitudinal Optical Micrograph

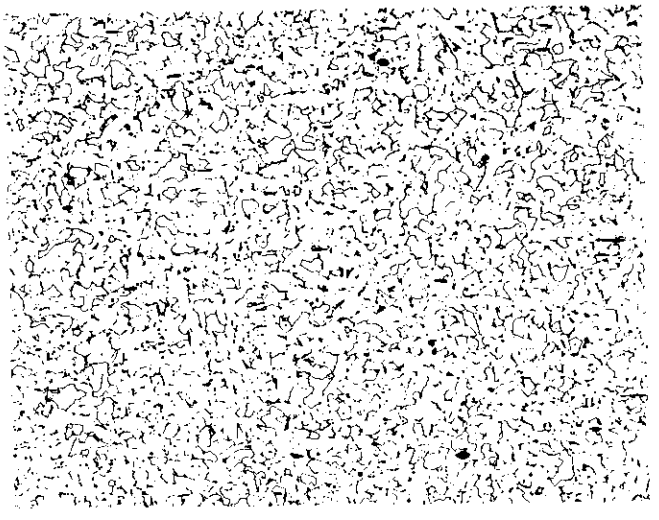
Figure 6

Nomadic Plate, Transverse Optical Micrograph

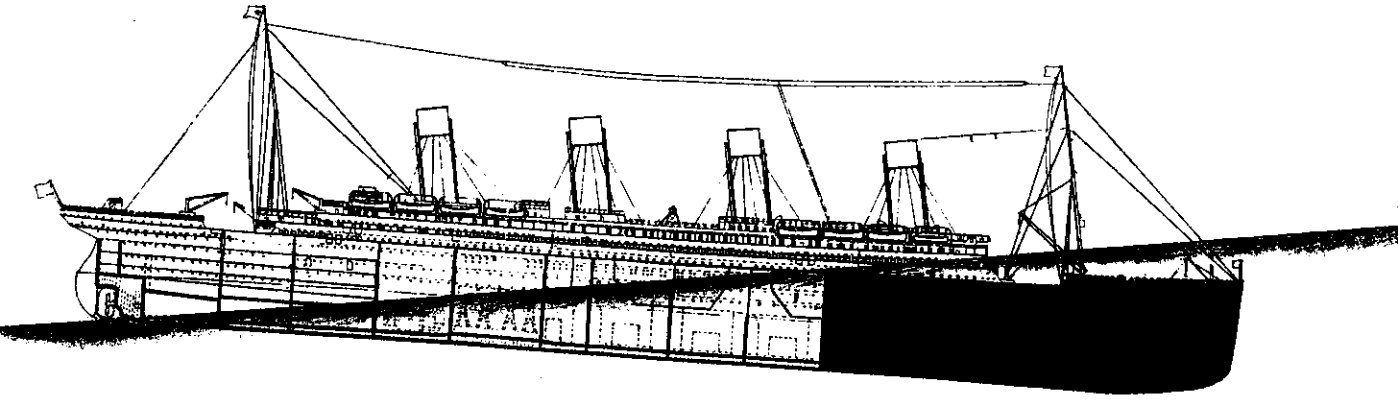
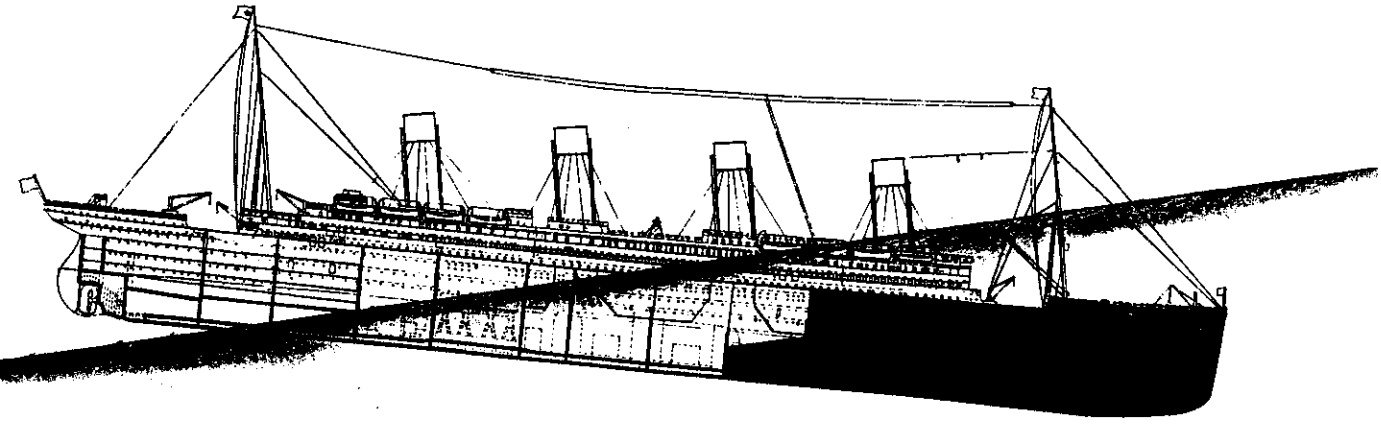
The flooding diagrams of Conditions C-6 and C-7 from Reference [5].

The values for the bending moment and shear diagrams were done for three flooded conditions, ultimately with the forecastle and the forward portion of C Deck submerged (see Figure 7 from Reference [5]). The results are tabulated in Table 1.

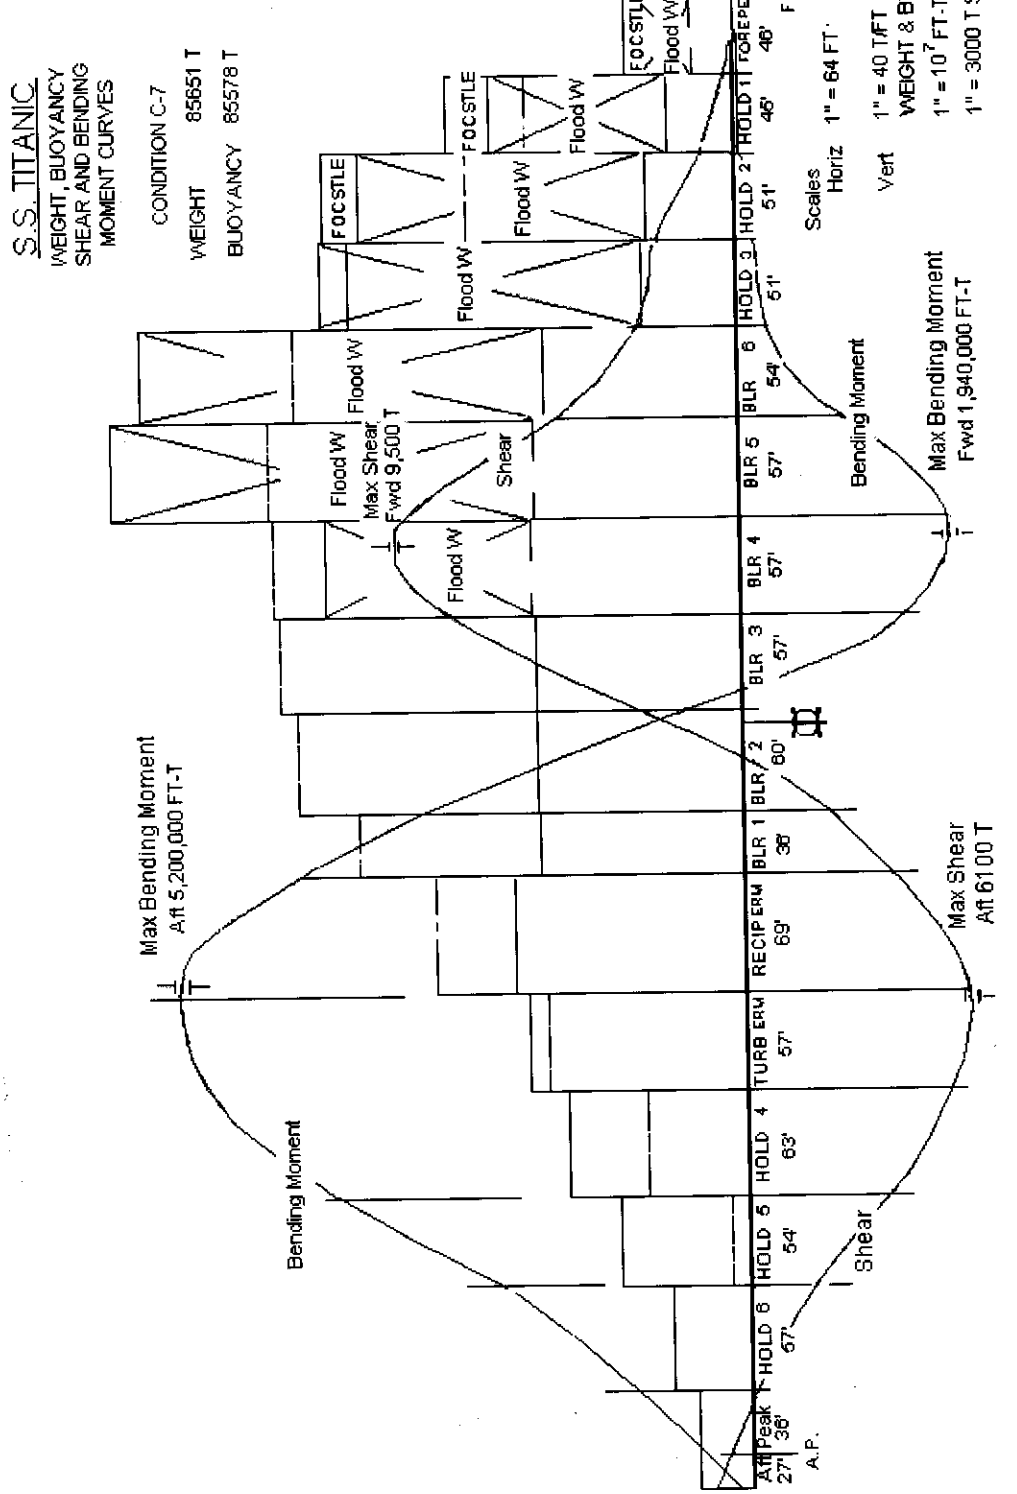
Figure 8

Load, Shear, and Bending Moment Curves, Condition 6 of Reference [5].

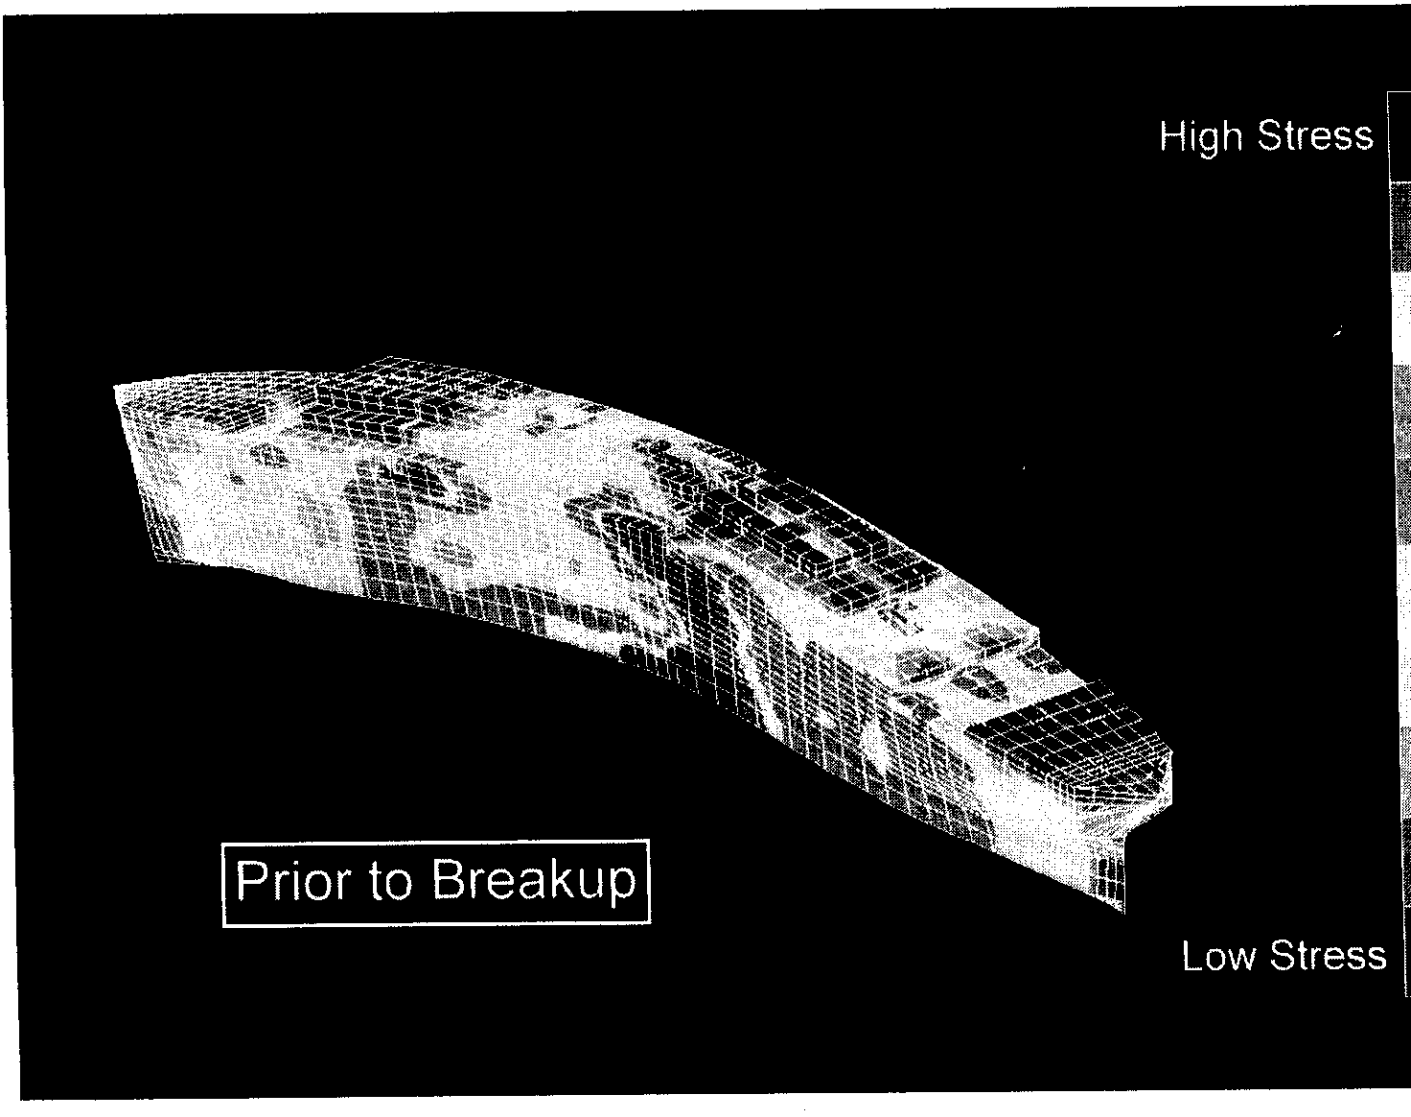
Figure 9

The failure of the main hull girder of the *Titanic* was the final phase of her sinking process. This began between 0200-0215 and started somewhere between stacks numbers 2 and 4. The finite element analysis indicates that the plate failures might have started around the second expansion joint or just aft of it. Stresses in the hull were increasing as the bow flooding continued and the stern rose from the water. Detailed examination of survivor testimony and underwater surveys have confirmed that the forward expansion joint was opened up. This situation while the ship was still on the surface is certainly an indication of the significant stresses induced by the flooding of the forward part of the hull. A review of the stresses from the finite element analysis in this area confirm that the stresses are well above the material yield stress.

Finite Element Model Results of *Titanic* "Before Breakup".

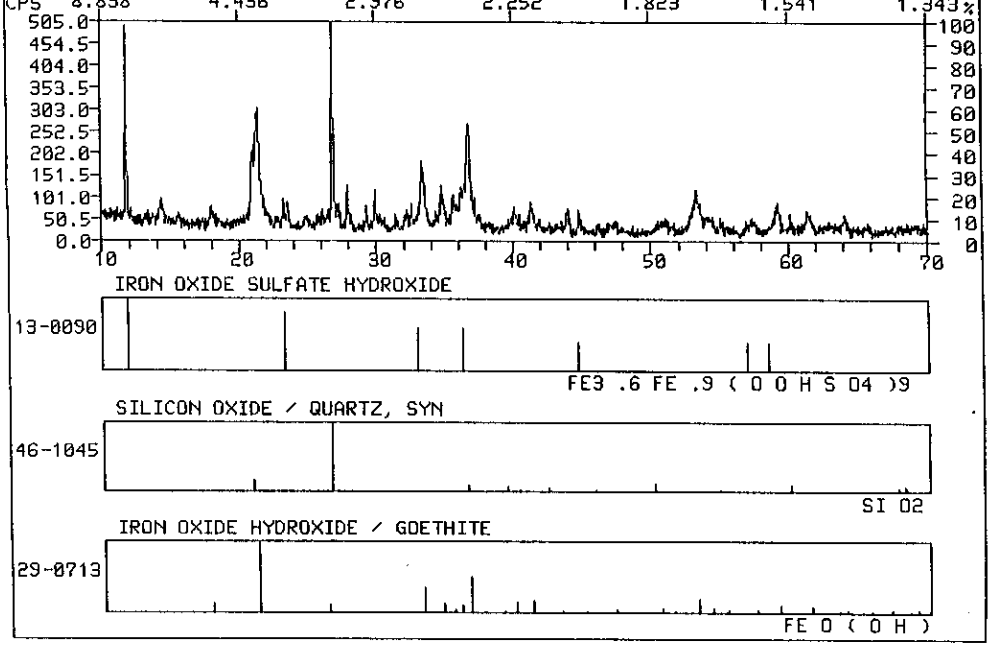
Figure 10

Mr. Scott Miller of the Department of Metallurgical Engineering at the University of Missouri-Rolla examined samples of rusticles using a scanning electron microscope. He performed elemental analysis, as well as semi-quantitative analysis. The result is given in Figure 10. As expected, Iron (Fe) is the dominant element present, followed by Sulfur. The sulfur is present as the sulfate ion, SO_4^{--}, could be from the sulfur in the steel or more likely from the sea water which has 884 part per million content of sulfur [12] The silicon will be shown to be mechanically entrained as silica, SiO_2, from the ever-present sand at the ocean bottom.

Elemental Analysis and Semi-quantitative Analysis of a Rusticle.

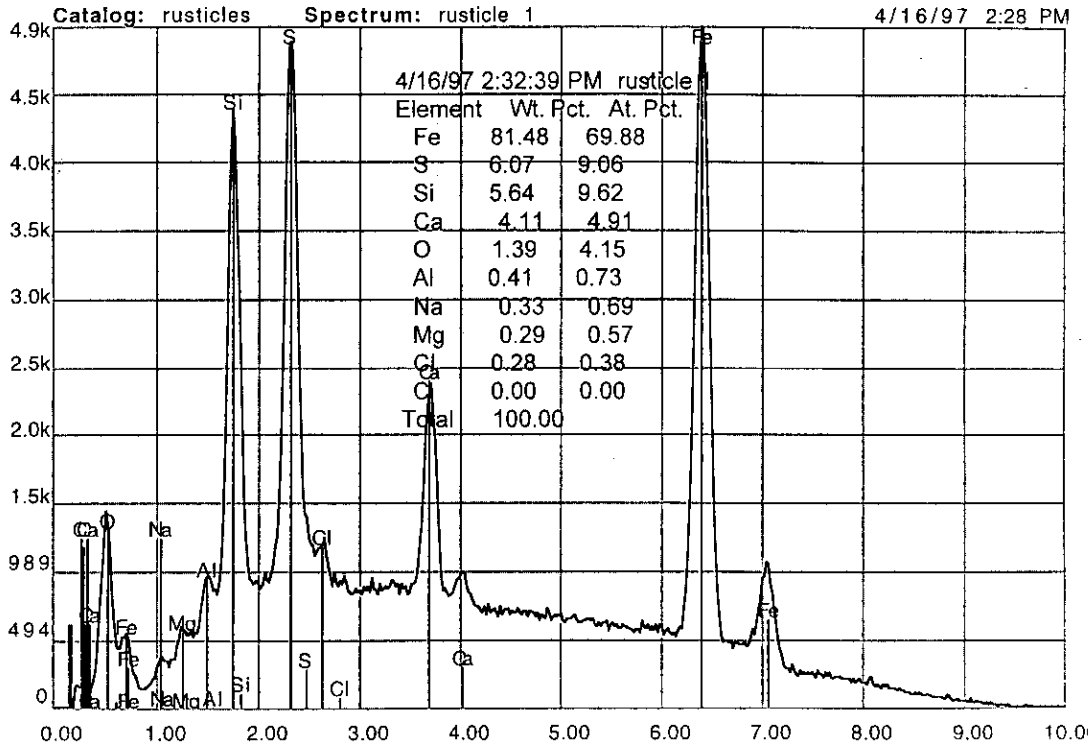
Figure 11

Dr. Mark Shumsky of the Materials Research Center at the University of Missouri-Rolla performed x-ray diffraction determinations to identify the compounds in a sample taken from a rusticle and from a massive piece of the corrosion product taken from a piece of steel. The same three compounds were found in these two samples, but in differing concentrations in each sample; silica, which is sand and discussed in the previous paragraph, goethite (FeO(OH)), and iron oxide sulfate, also known

Diffraction Pattern of a Rusticle.
